The Building Limes Forum Ireland Newsletter

Editorial

Welcome to our September 2013 edition of the Building Limes Forum Ireland Newsletter. We hope everyone is in great spirits and fully refreshed after the holiday season and superb summer sun.

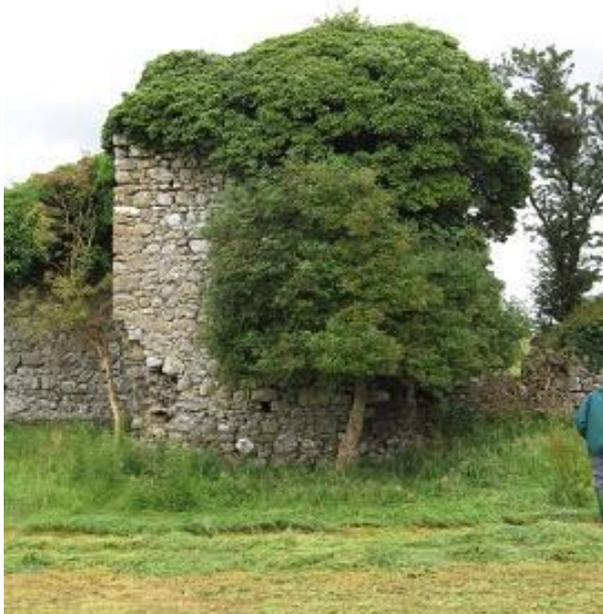
Before Work commences

By 2008 when Blackwood Associates carried out the first site inspection it was found that all remaining structures on the site were densely covered with an invasive and damaging ivy. In areas it was difficult to identify what stonework remained under the vegetation. It was decided to carry out conservation and stabilisation works to one of the towers on the town wall as a pilot scheme, funded by the Heritage Council, so that the scope of the damage could be established and a suitable conservation methodology prepared for carrying out the works to the entire structure. During the works it was found that roots were deeply embedded in the structure and localised dismantling was necessary to remove these roots. Serious fabric disturbance was uncovered on the wall tops, particularly on the western face of the tower; the lintel of the central opening and much of the stonework was in a very precarious state with substantial fabric loss caused by the ivy

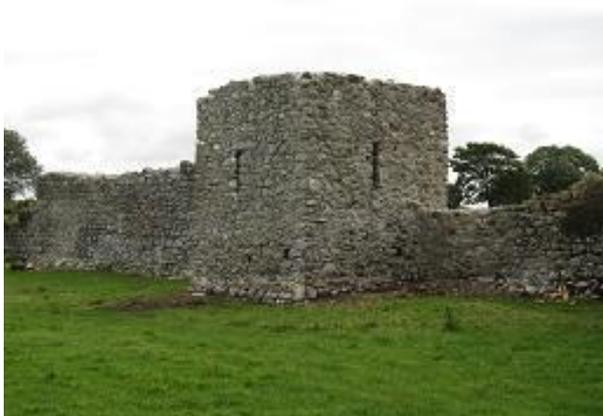
And after

On completion of the stabilisation works a limited pointing programme to the walls as well as pointing the entire wall top was carried out. All sound mortar was retained and pointing applied only to areas where the mortar had degraded or lost completely. It was essential that the wall tops were finished in such a way to shed rainwater as quickly as possible to reduce water penetration. The core stonework was raised slightly to provide a fall to each side and eliminate the potential for ponding and water ingress on completion. While it is not desirable to alter any historic stonework it was felt that it was essential in this case to prevent water ingress through the

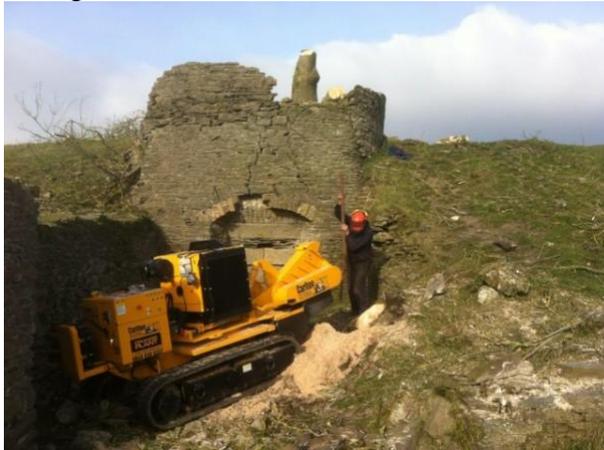
The two ash trees finally met their demise in February 2013. At least 65 growth rings have been counted in the stump of the larger tree growing out of the shaft.

Careful excavation around the kiln then followed. The draw area was buried in approximately half a metre of debris. The ash tree stump growing from the south side of the draw area came out quite easily as it had been growing on the debris rather than into the walls or floor.

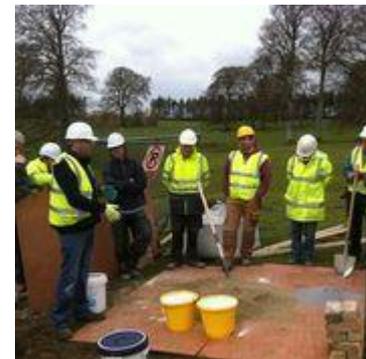
Craig and Hot lime mixing.

McElveen, previous chair of BLFI to use more indigenous lime reducing somewhat the reliance on imported lime from Europe. Hence the first workshop developed into a hot lime workshop and indeed we have been using hot lime mixes throughout the repair works to the external walls. The internal shaft wall is another matter!

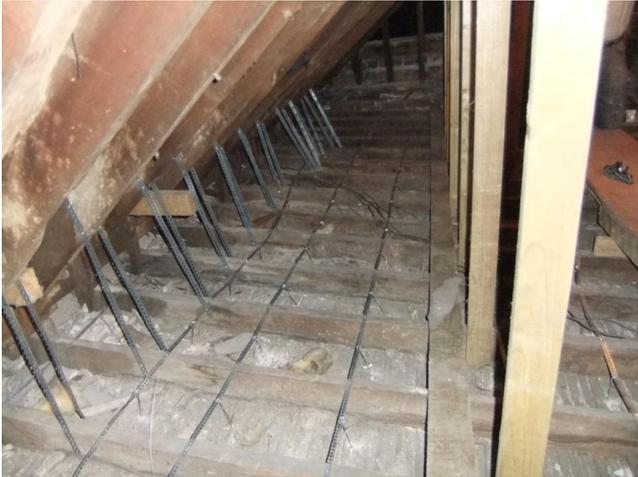
The ceiling structures throughout the building span between 5.8 and 6.1m and are formed of small red deal (*Pinus sylvestris*) ceiling joists of approximately 80-120mm deep x 45-55mm wide. This form of very long span small ceiling joists are particularly common in Ireland.

The ceiling joists were working extremely hard to hold the lath and plaster ceilings and in places had deflected over 100mm and resulted in significant cracking to the plasterwork. This cracking was particularly noticeable along the cornice running parallel to the joists and as diagonal ceiling cracking to the corners of each room. The severe central deflection was much less noticeable in the room but became apparent on entry to the attics.

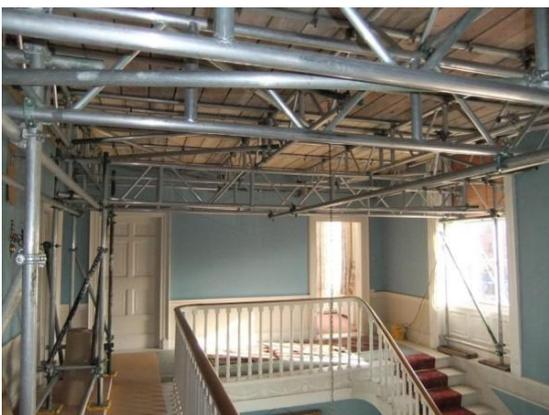
In 2011 repair works were instigated, firstly with the more damaged flat and accessible rear ceilings and completed in 2012 with the particularly inaccessible vaulted main stair hall ceiling. All of the repairs commenced with assessment of the ceiling timbers and in some cases temporary support. The roof structure above the ceilings was known to be of reasonable condition and

structural integrity and therefore could be used as the permanent support structure for the ceilings below without the need for insertion of additional primary structure.

Some local replacement of collar ties within the roof was undertaken and then the ceiling joists were hooked up to these and the rafters by means of timber hangers and metal bands. Care was taken to hang new crawl boards for attic access onto the roof structure wherever possible rather than impose maintenance loads onto the ceiling structure.

Then, and only then, the ceiling lath and plaster repairs were instigated in the form of washers below set into the plaster wired off metal bands over the joists.

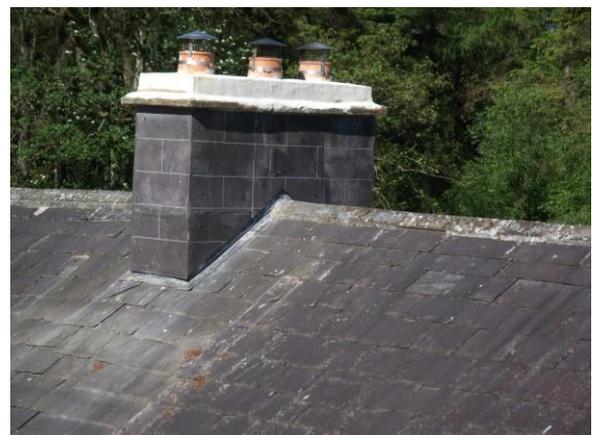
Restoration of chimney at Augnagaddy House Ramelton, using reclaimed Bangor Blue Slates to match existing – Tir Conall Restoration/ Sean Brogan.

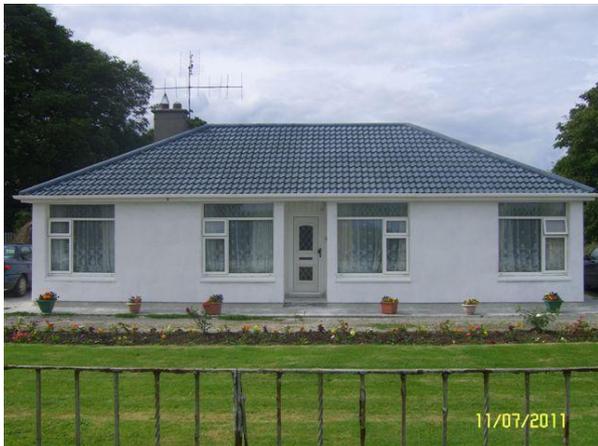
Hemp/Lime Render on bungalow- Brendan Kelly

Brendan writes: This house was a 1970s prefab. The walls are 2 inch concrete slabs dry lined on the inside with half inch plasterboard. Zero insulation. We put six inches of hemp/lime insulation and finished it with a sand and lime plaster properly floated and finished. The owners of this house can be contacted directly and the project can be viewed by appointment. The owners will

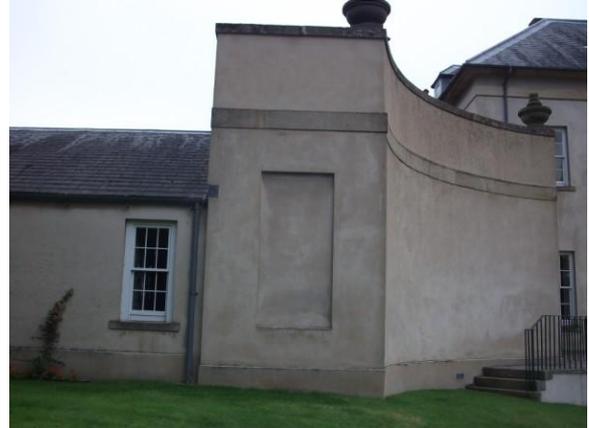
New Lime render comprising of carefully selected lime, aggregates and oxide pigments to match existing render – Oakfield, Raphoe, Co. Donegal. By Sean Brogan.

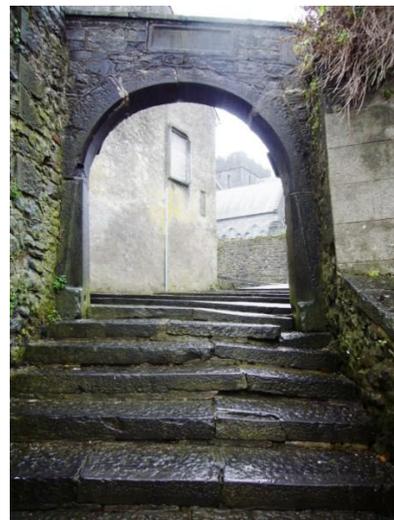
St Canice's arched gateway is located at the top of St Canice's Steps leading from Dean Street in the city, up to the Coach Road at St Canice's Cathedral. It was built in 1614, and the flight of twenty-six limestone steps and arch are the medieval ceremonial route

The arch measures approximately 2050 mm in width and 2550 mm high at the centre point. It is of stilted design and the side column impost is approximately 360 mm wide. It is constructed with four granite cut-stone voussoirs with no keystone, the two outer being springers mounted on cambered cut-stone column imposts. The side spandrels and crown, which contains a plaque either side, are constructed of random rubble stone with a coping over.

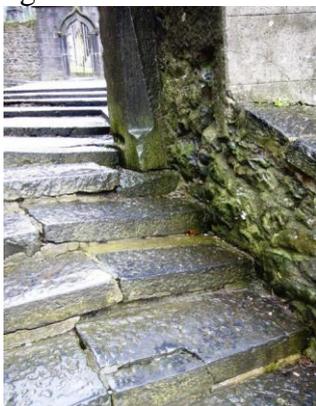
On initial examination the arch appeared stable albeit off the perpendicular with possibly a slight twist or moment. There was much evidence of progressive settlement which was adversely affecting its structural integrity and exerting considerable stress. There was also evidence of some attempted repairs in the past and which had little remedial effect. Previous filler and pointing repairs, some of which had used incorrect materials, continued to show signs of failure acting as a *tell-tales* of progressive movement.

Considerable collapse had occurred of the steps at the base of the western column impost and which in turn had undermined the column causing support failure for this side of the arch. This resulted in the opening of the joints in the vicinity of the voussoirs and impost itself, as well as causing structural cracks in the infill masonry.

The cause of this progressive collapse which appeared to have been taking place over some considerable time was initially found to be due to surface rain water cascading down the

steps in storm conditions due to the failure of a shore drain to the upper western side of the arch. When this occurred water penetrated between the joints of the steps into the substrata material which in turn lost its compressive strength experiencing a change in viscosity causing permanent and progressive settlement, thus failing to give support to the steps and reducing their level and posture, as well as undermining the foundation material of the western column impost.

On further investigation, however, it was discovered that there was a failure of an ancient but still active underground storm drain which ran under the column impost. This released storm water causing severe scouring creating a large cavity under the column impost adding substantially to its further deterioration and ultimate foundation collapse which could have been imminent.

Being a Recorded Monument and a Protected Structure dismantling and re-building the arch was not an option. A timber cradle was designed to clamp the arch which was suspended from above by two universal beams spanning from the top of adjacent walls. This held the arch firm and in situ while the steps could be removed and the foundation of the western column excavated giving access to the storm drain for repairs and in providing a new reinforced concrete foundation for the column impost, all of which was successfully completed. The adjoining steps were reset and levelled with repairs been undertaken to the remaining flight of steps.

On the removal of the cradle support, the arch and adjoin walls were repaired and re-pointed using various hot-lime mixes. These comprised non-hydraulic quick lime gauged with NHLs to impart various degrees of hydraulicity. Hot-mixes were chosen for their strong adhesion and good workability as well as load supporting qualities and proven durability. From samples examined of the original mortar it was also a more authentic replication of what had been used in medieval times during the construction of the arch.

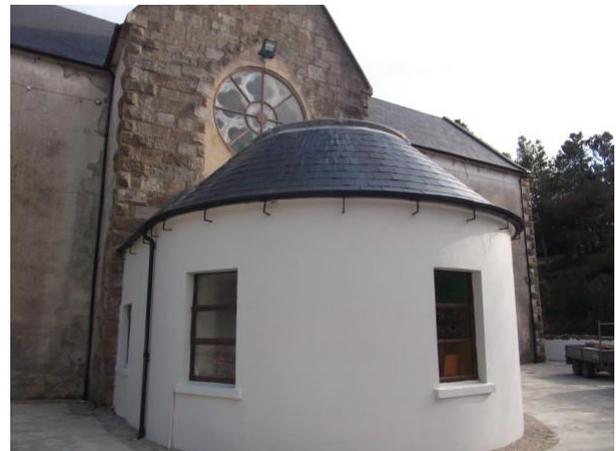
Radius cast iron guttering and lime render to Old Church at Derrybeg Co. Donegal – Sean Brogan

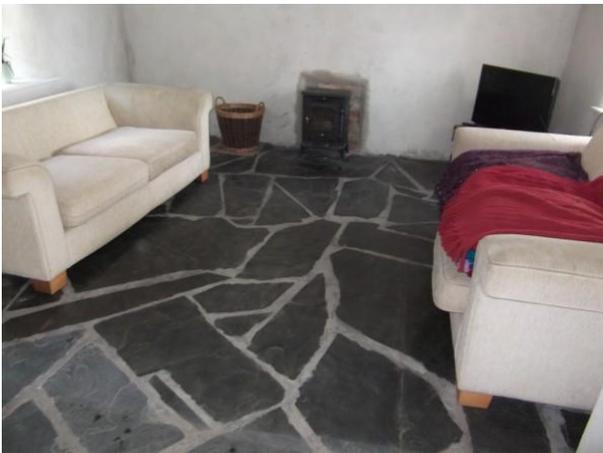
Traditional Lime and flag floor – Co Donegal – Sean Brogan

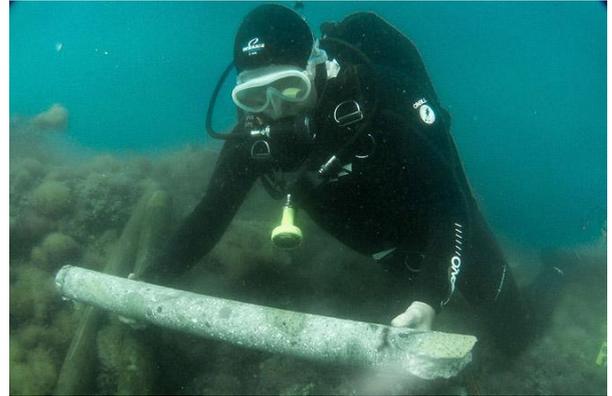
Chris Brandon of the ROMACONS project collects a sample of ancient Roman concrete drilled from a breakwater in Pozzuoli Bay, near Naples, Italy. The breakwater dates back to around 37 B.C. (D. Bartoli photo, courtesy of J.P. Oleson)

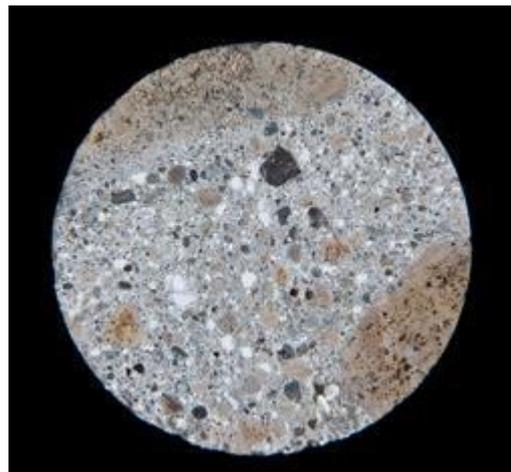
Sample of ancient Roman maritime concrete from Pozzuoli Bay near Naples, Italy. Its diameter is 9 centimeters, and it is composed of mortar formulated from lime, volcanic ash and chunks of volcanic tuff. (Carol Hagen photo)

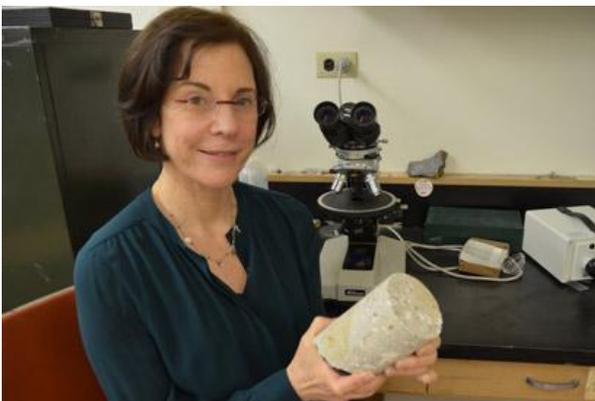
Marie Jackson holds a 2,000-year-old sample of maritime concrete from the first century B.C. Santa Liberata harbor site in Tuscany. (Sarah Yang photo)

The research team was led by Paulo Monteiro, a UC Berkeley professor of civil and environmental engineering and a faculty scientist at Berkeley Lab, and Jackson, a UC Berkeley research engineer in civil and environmental engineering. They characterized samples of Roman concrete taken from a breakwater in Pozzuoli Bay, near Naples, Italy.

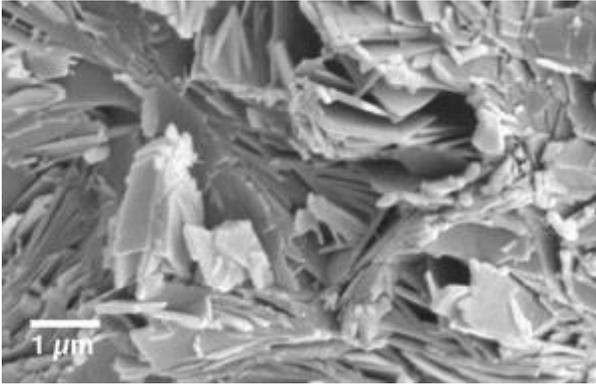
This scanning electron microscope image shows crystals of a rare mineral, Altobermorite, magnified about 25,000 times. UC Berkeley researchers characterized Altobermorite in samples of Roman concrete. (Image courtesy of UC Berkeley)

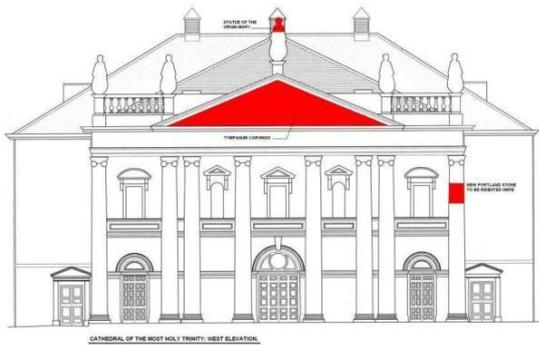
Location of eroded masonry and falling debris –above the main entrance!

Restoration work at the Holy Trinity Cathedral using stone grafting, plastic repair mortars, shelter coats and lime washes. Lime used throughout under the guiding hand of Bill Walsh, Architect from CJ Falconers practice in Waterford.

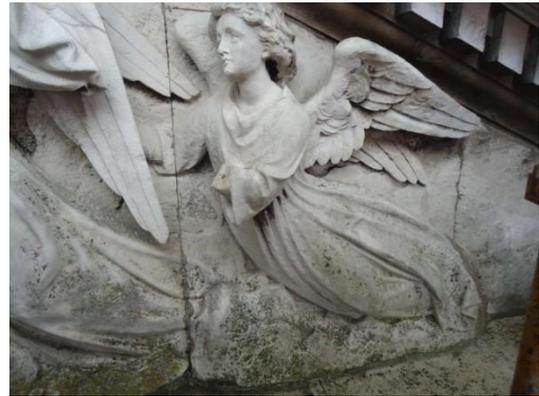
Above – Before work commenced with Angels hand missing, facial features eroded, inappropriate cement re-pairs, ponding of water in bas-relief, erosion and decay widespread.
